Re: File Closure, Notice of Intent, Dan Shumway, Lucky/Golden Chantz Mine, UTU-68057 (S0370064), Recapture Canyon, San Juan County, Utah

Date: 11/16/09
To: Minerals File UTU-68057
From: Ted McDougall, Geologist
Subject: Surface Management Site Inspection, Dan Shumway, Golden/Lucky Chantz Mine, UTU-68057 (E/037/0064), Recapture Canyon, San Juan County, Utah.

Inspection Report Minerals Regulatory Program April 28, 2010

Mine Name: Golden/Lucky Chance	Permit Number: S/037/0064
Operator Name: Dan Shumway	Inspection Date: April 14, 2010
Inspector(s): T Munson	Time: 4-5 PM
Other Participants: none	Mine Status: regraded

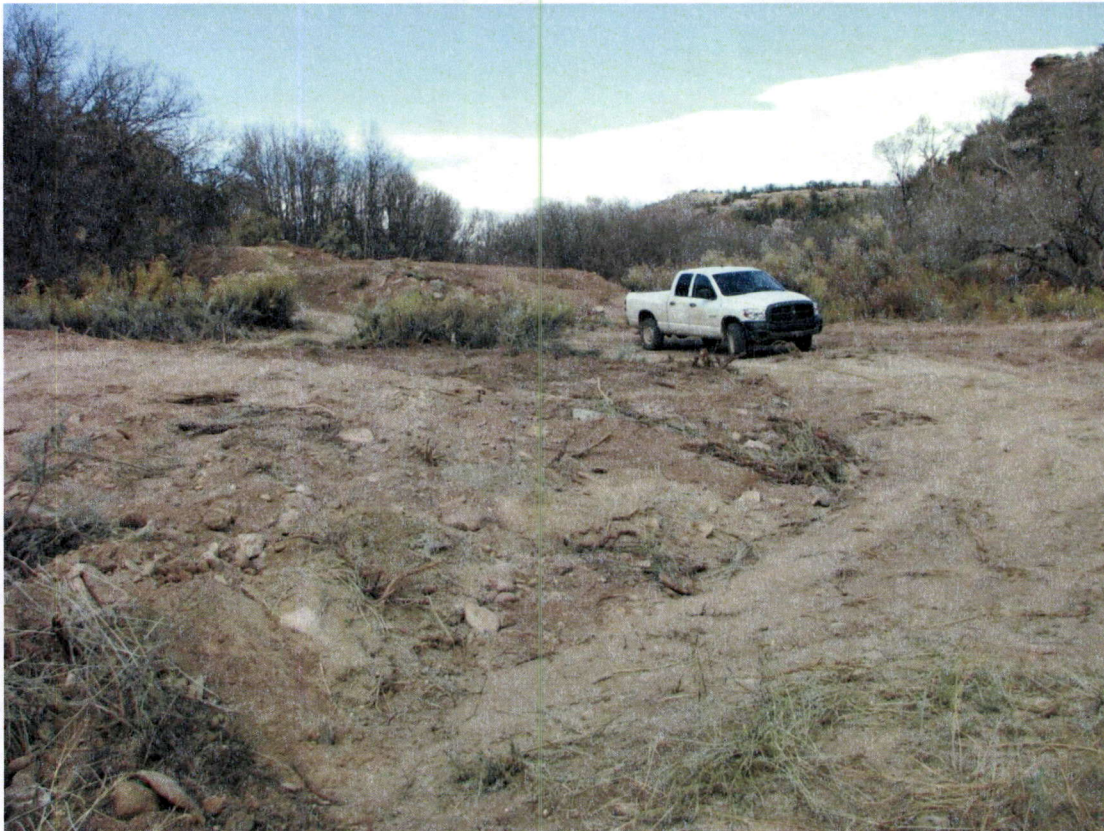
Lucky/Golden Chantz Reclamation. Equipment has been removed from the small site and the site has been graded and topsoiled.

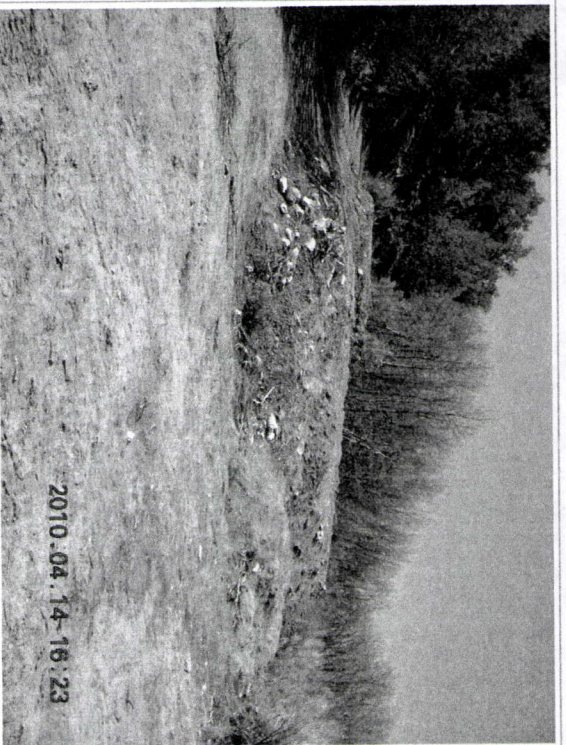
Regraded pile next to pipeline access road

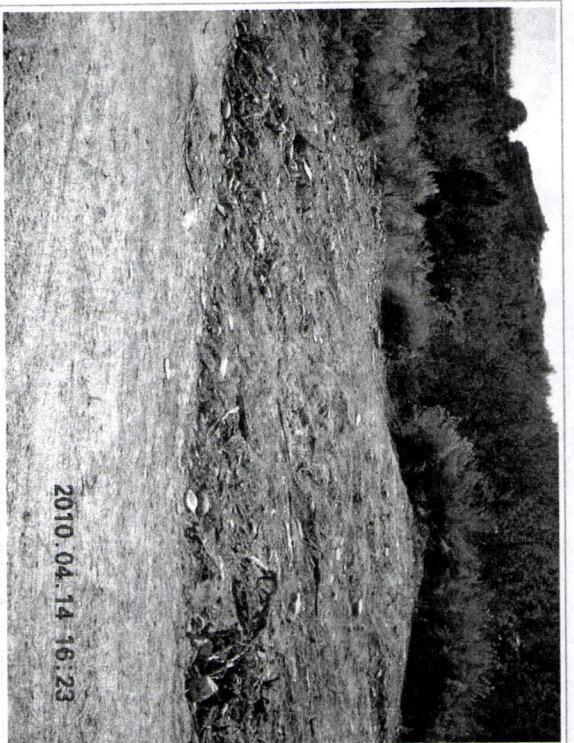
Regraded pile
